School Bus and Truck Collision at Intersection
Near Chesterfield, New Jersey
February 16, 2012

Accident Report

NTSB/HAR-13/01
PB2013-106638

The National Transportation Safety Board (NTSB) determines that the probable cause of the Chesterfield, New Jersey, crash was the school bus driver’s failure to observe the Mack roll-off truck, which was approaching the intersection within a hazardous proximity. Contributing to the school bus driver’s reduced vigilance were cognitive decrements due to fatigue as a result of acute sleep loss, chronic sleep debt, and poor sleep quality, in combination with, and exacerbated by, sedative side effects from his use of prescription medications. Contributing to the severity of the crash was the truck driver’s operation of his vehicle in excess of the posted speed limit, in addition to his failure to ensure that the weight of the vehicle was within allowable operating restrictions. Further contributing to the severity of the crash were the defective brakes on the truck and its overweight condition due to poor vehicle oversight by Herman’s Trucking, along with improper installation of the lift axle brake system by the final stage manufacturer—all of w

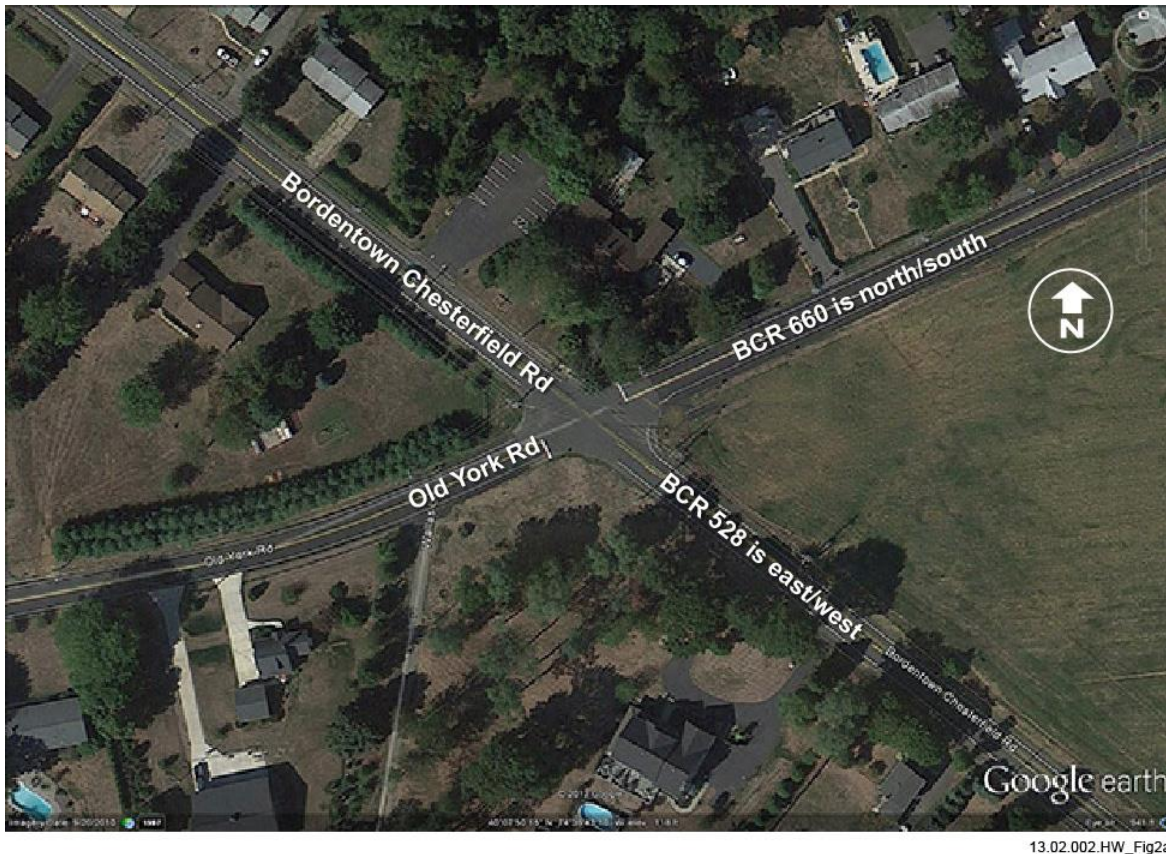
Figure 2. Aerial view of BCR 528–660 intersection, with Bordentown–Chesterfield Road running east–west and Old York Road running north–south. (Google imagery, September 20, 2010)

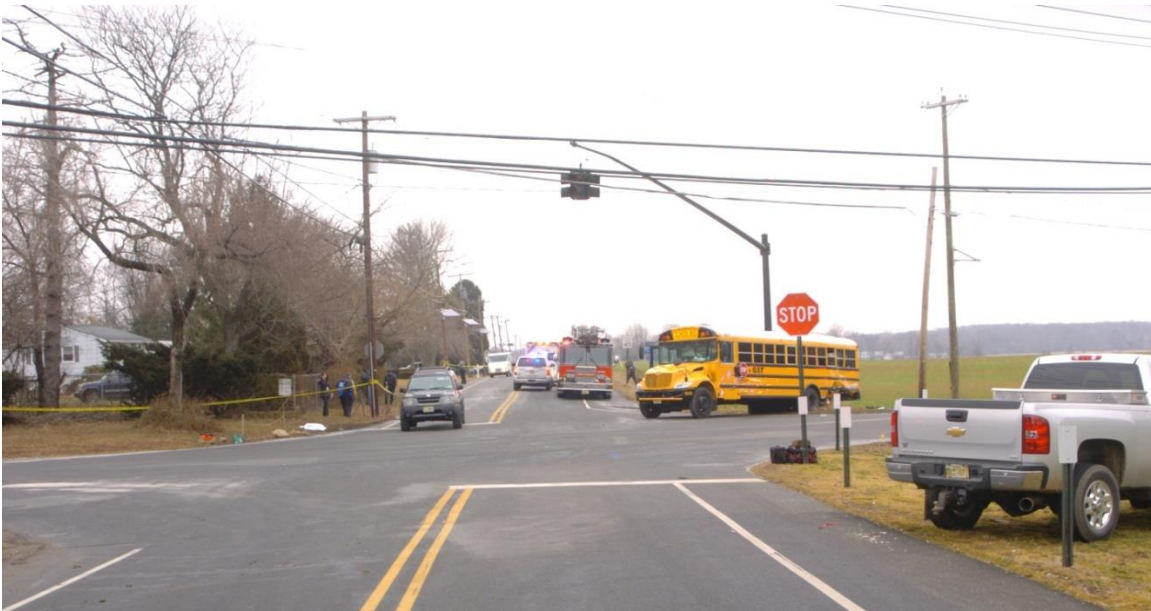
Figure 3. School bus at BCR 528–660 intersection on February 16, 2012. (Courtesy of Burlington County Prosecutor’s Office)

The school bus, while rotating counterclockwise, continued moving another 50 feet to the northeast corner of the intersection, where its right side (behind the rear axle) struck a metal pole supporting a flashing intersection control beacon. The bus came to rest upright and facing west. The truck continued another 188 feet after impact and came to rest in a field northeast of the intersection, just off BCR 528.⁶ (See figures 3 and 4.)

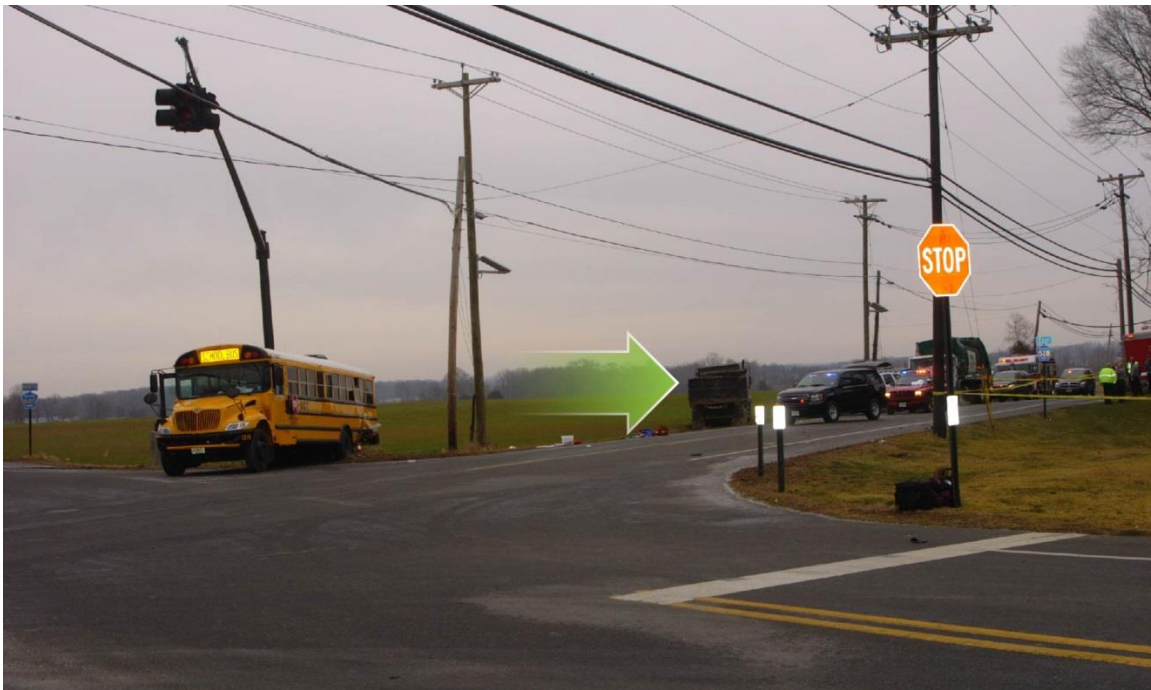
Figure 4. School bus and truck (marked with green arrow) at final rest. (Courtesy of Burlington County Prosecutor’s Office)

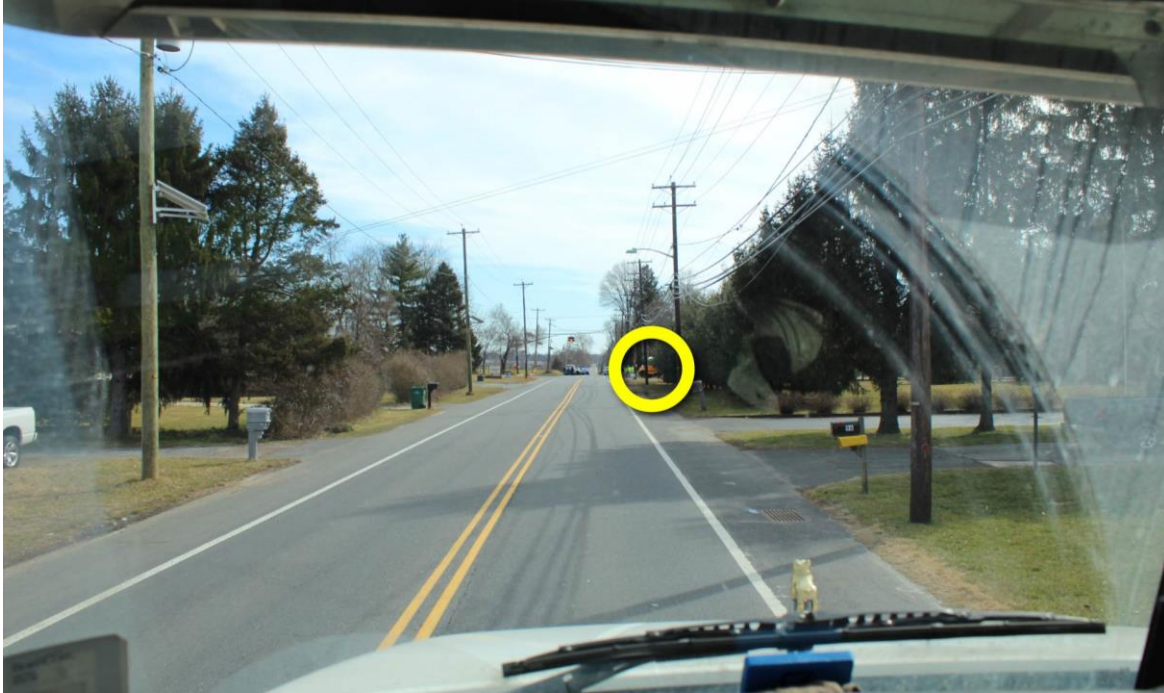
Figure 5. Truck driver view of BCR 528–660 intersection from 463 feet, showing exemplar school bus marked with yellow circle.

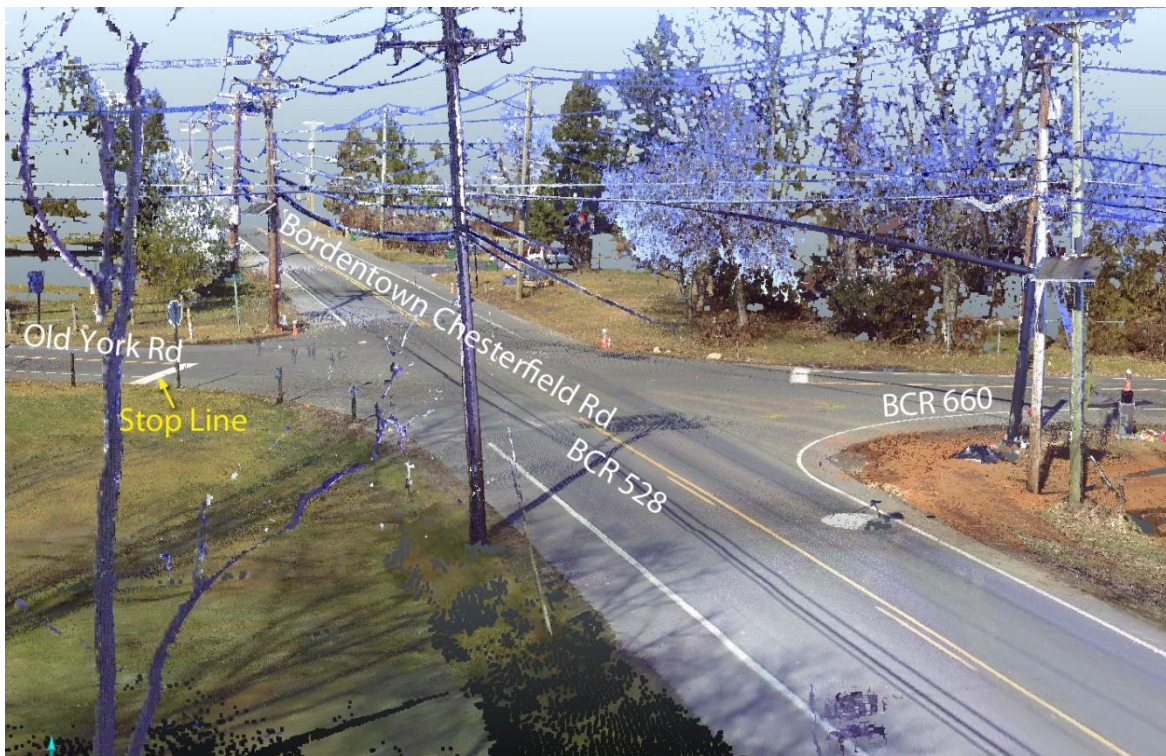
Figure 6. FARO Focus 3D laser scanner image of crash intersection facing westbound BCR 528, showing north and south lanes of BCR 660.

The truck driver said that he was familiar with the BCR 528–660 intersection. In describing the crash, he stated that he was driving about 45 mph eastbound on BCR 528, approaching the intersection. He saw the school bus but could not tell whether the bus had just pulled up or whether it had made a complete stop because a line of trees obstructed his view of BCR 660 to the south. (See figure 5.) He said that he observed the bus as it entered the intersection and attempted to avoid the collision by steering to the left. He then applied the brakes and struck the school bus. (See figures 6 and 7.)

The crash scene, related environment, sight conditions, and both vehicles were examined by the NTSB and scanned using a FARO Focus 3D laser scanner. The scanner was placed on a tripod and automatically rotated 360 degrees to record its entire surrounding environment, emitting a laser beam to a range of about 300 feet. By keeping track of its position and orientation, and measuring the time it takes for the beam to reflect off objects, the scanner creates a three-dimensional view. Precise measurements can be obtained from the scans, such as the length of tire marks, deformations in damaged vehicles, and locations of site obstructions.

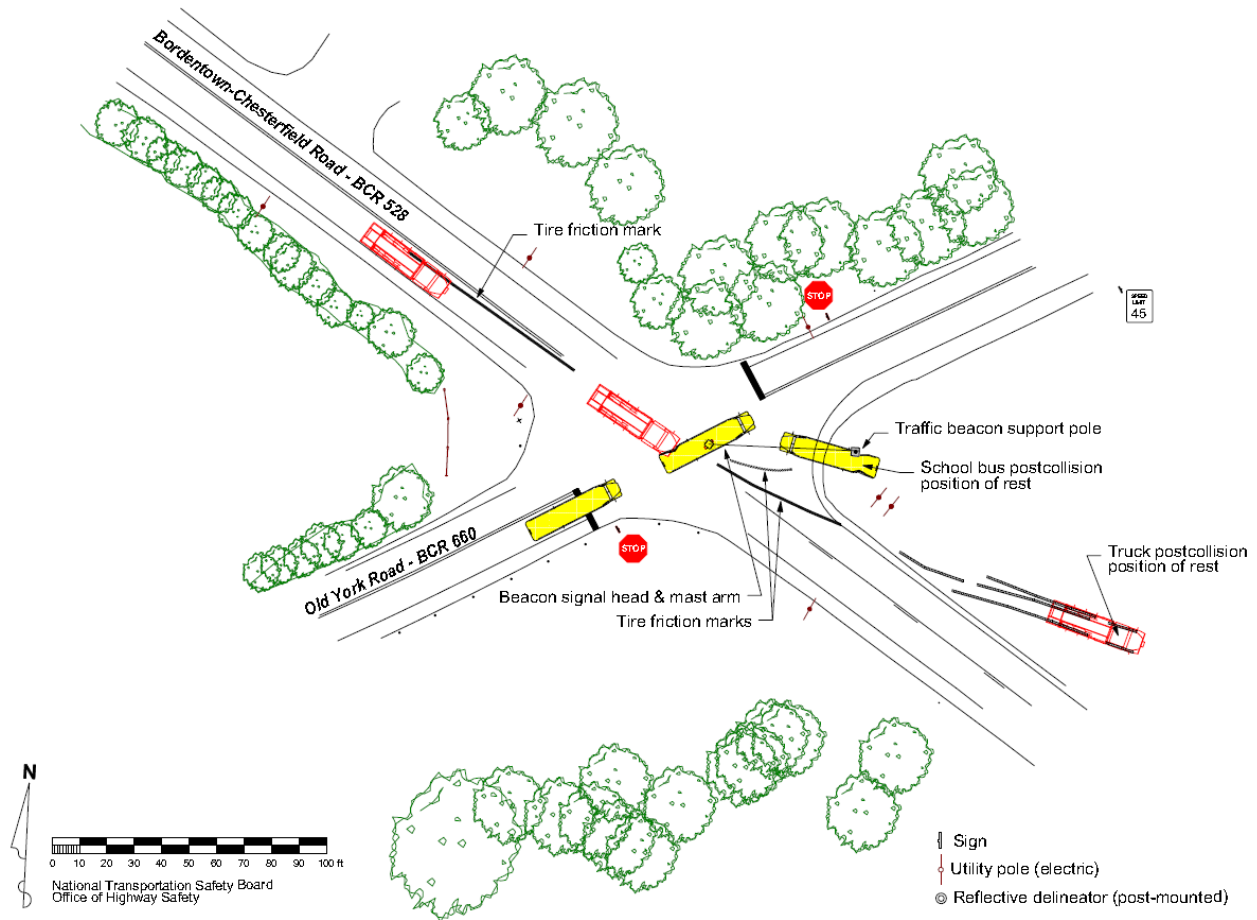
Figure 7. Crash scene diagram.

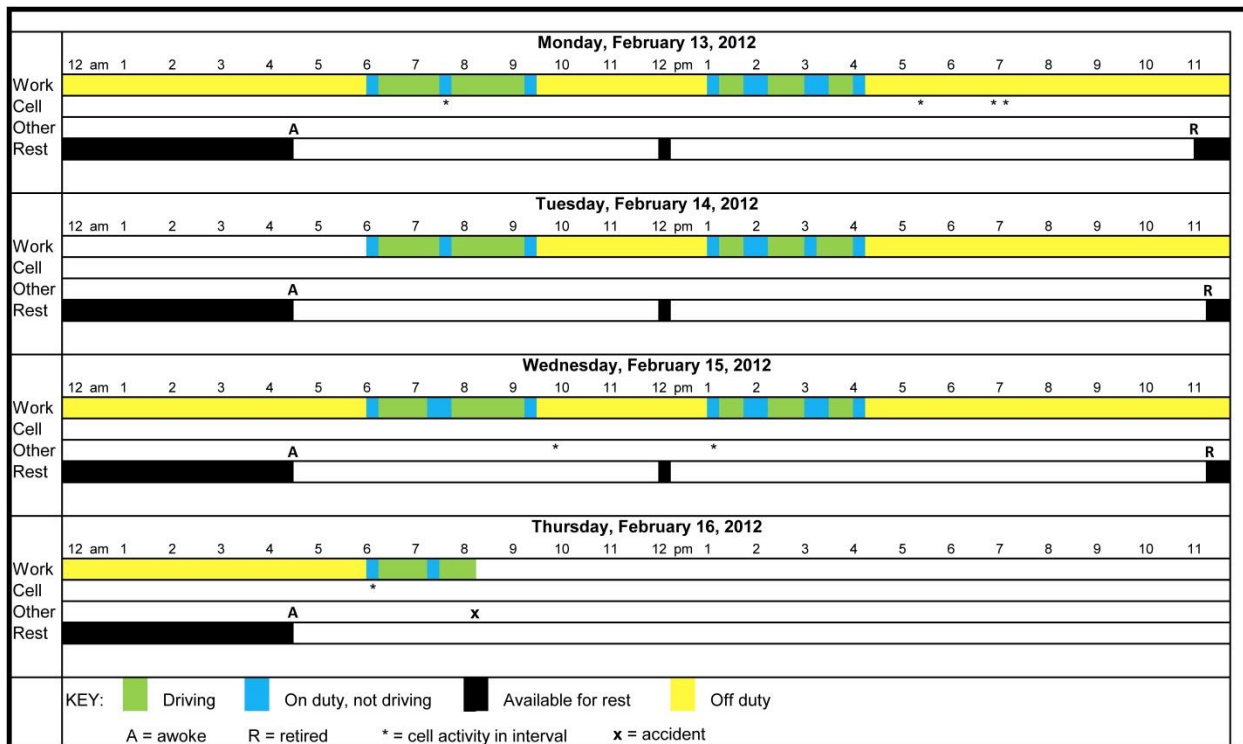
Figure 9. Summary of school bus driver’s precrash duty schedule.

Figure 9 provides a graphic activity history for the three days preceding the crash and is based on information obtained during the school bus driver’s interview, from his work schedule, and from his cell phone records. The bus driver kept a fairly regular sleep schedule, retiring about 11:15 p.m. and awaking at 4:30 a.m. on each of the three days prior to the crash, which provides about 5.25 hours of time in bed. On his days off, he would usually go to bed at approximately the same time but awake about 6:30 a.m. When asked about napping, the bus driver told investigators that he took a 10–15 minute nap every day at lunch, which he found to be refreshing. He stated that he has never been diagnosed with sleep problems, including insomnia, obstructive sleep apnea (OSA), or restless legs syndrome. During the postcrash interview, the bus driver was upset over the loss of his brother-in-law, who had died the Tuesday before the crash.

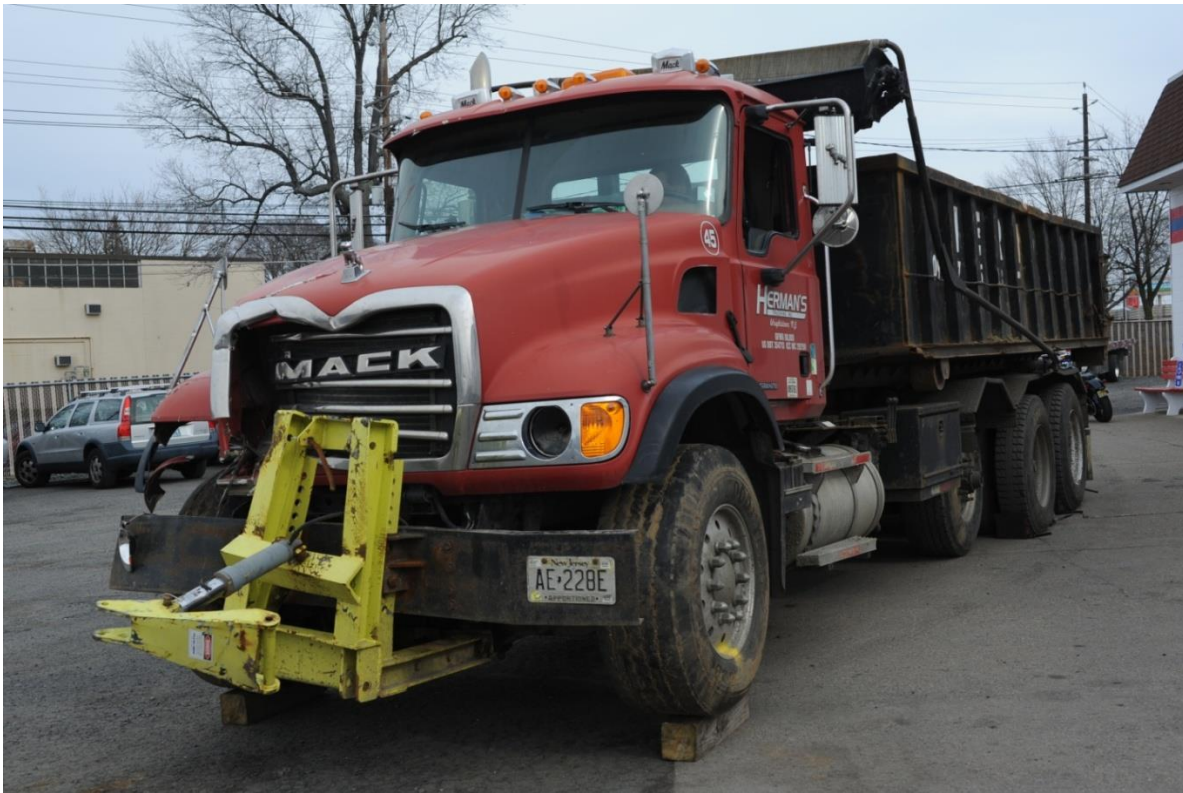
Figure 10. Front view of damaged truck.

Damage to the truck as a result of the collision consisted of deformation to the front steel bumper (rearward crushing deformation), the grill and radiator, the red fiberglass hood, the right headlight, and the snowplow mount attachment. Maximum deformation was measured at 10 inches rearward, and the damage spanned a 77-inch width across the front. (See figure 10.) Contact damage was observed on the snowplow mount, along with “school bus yellow” paint transfer. The right upright of the snowplow mount was displaced rearward a greater distance than the left upright, causing a twisting rearward displacement, which resulted in an induced rearward crush to the center portion of the steel bumper. The outer edges of the vertical uprights of the snowplow mount are approximately 25 inches apart, and the rear mounts for the lifting plate are located approximately 48 inches above ground level.

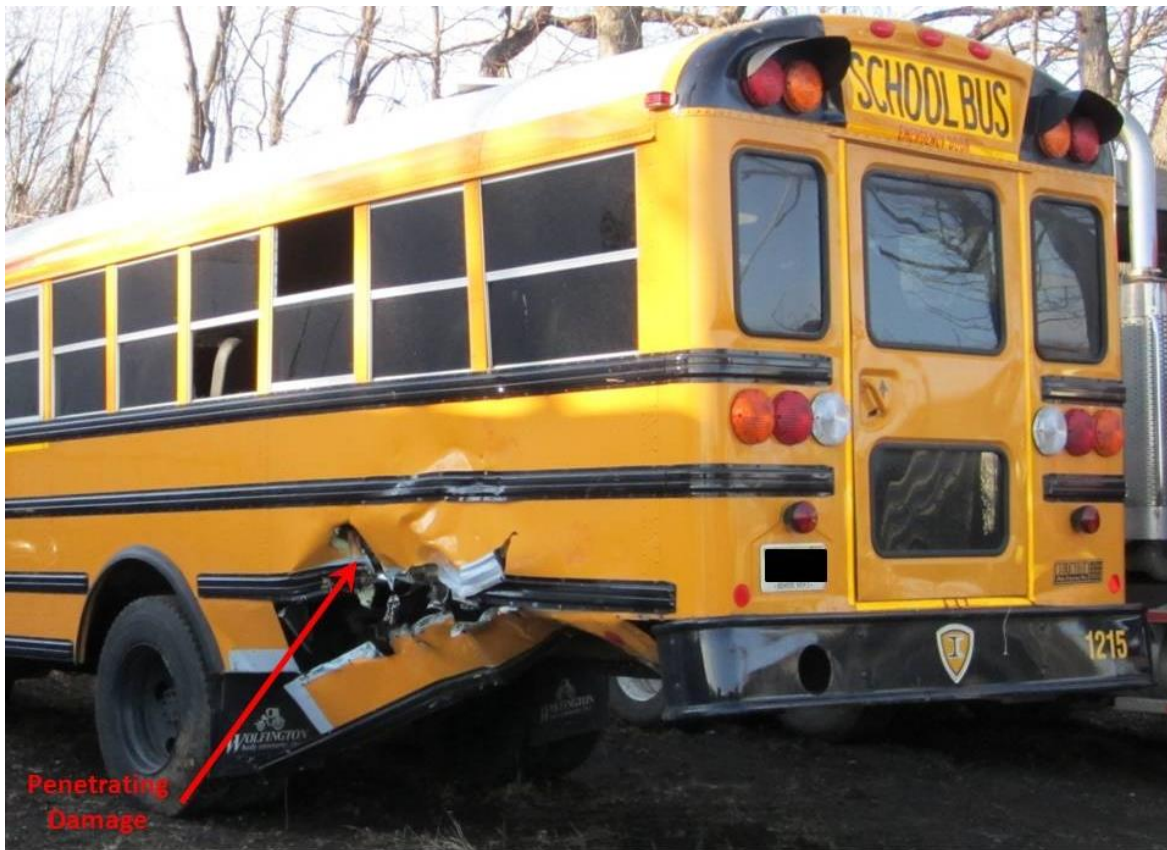
The primary mechanism of physical damage to the school bus occurred when the truck struck the bus on its driver side behind the rear axle. The damage measured about 74 inches in width and spanned a vertical height from the bottom of the bus body upward about 47 inches. The interior passenger compartment was penetrated at a height of 48 inches from ground level and 65 inches rearward from the rear axle. Postcrash maximum crush intrusion into the passenger compartment measured 17 inches. Red paint transfers from the truck onto the side of the bus extended vertically 67 inches from ground level, and yellow paint transfers from the truck's snowplow mount extended vertically 71 inches.

The school bus was equipped with 11 passenger area windows on the left and right sides.⁵⁴ The lower glazing panel in window 8 on the left side was broken just forward of the truck contact damage area. The floor was buckled upward at rows 7–10, with a maximum height of 10 inches. A 12- by 12-inch hole was located in the bus sidewall on the driver side at row 9. (See figure 12.)

Figure 12. Damaged left side of school bus.

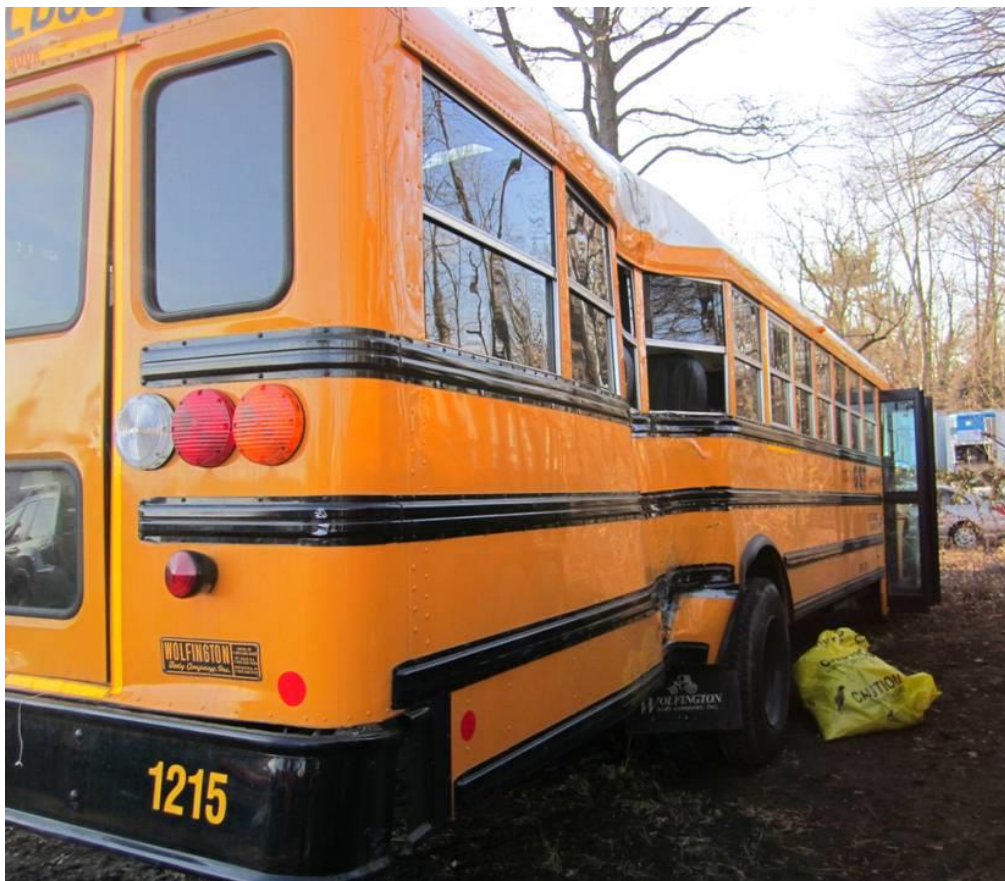
After being struck by the truck, the school bus then rotated and struck the traffic beacon support pole. A secondary area of damage was located on the right side of the bus behind the rear axle. This damage spanned a width of 30 inches and extended vertically from the bottom edge of the bus body up to the roofline. The intrusion crushed inward to a maximum penetration of about 10.4 inches (at seating row 8), near the roofline. On the right side, both the upper and lower glazing panels in window 9 and the lower glazing panel in window 8 were broken out in the area of contact. (See figure 13.)

Figure 13. Damaged right side of school bus.

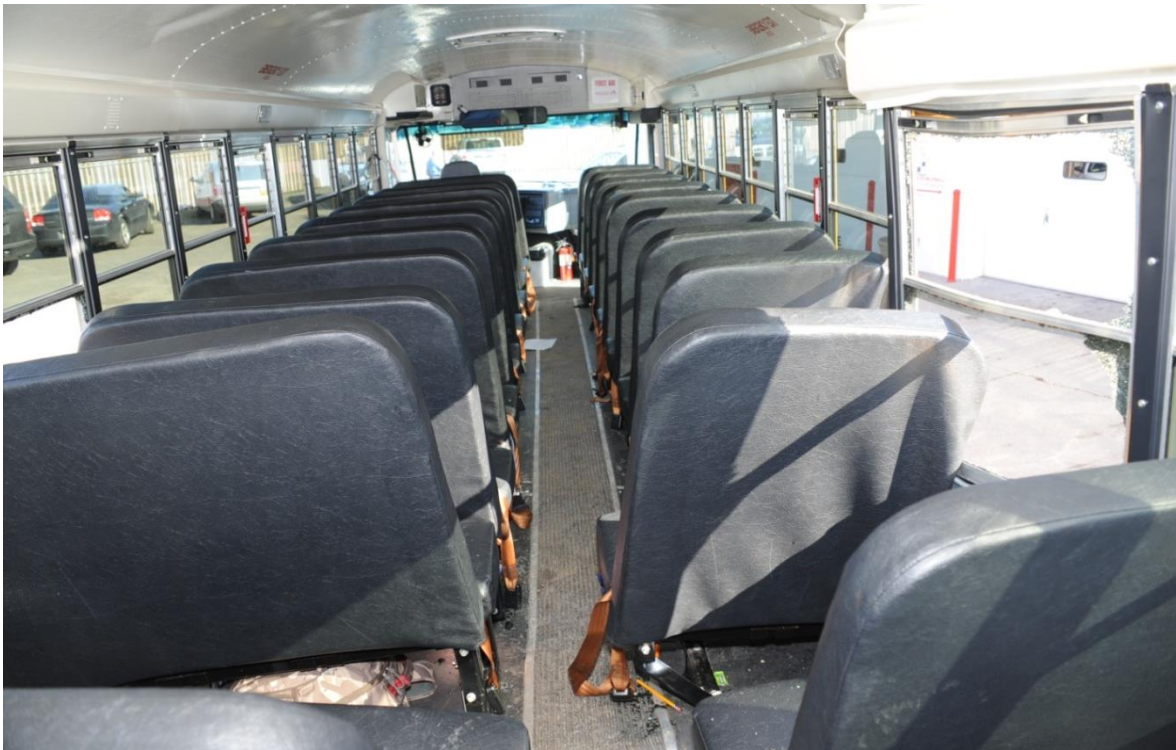
Each school bus seat shared a common base frame, attached to the floor via a forward and aft leg with anchor at the aisle position and to the sidewall via a forward and aft anchor at roughly the level of the seat pan. The left side bench seats measured 45 inches wide, while the right side bench seats measured 30 inches wide; all passenger seatbacks measured 28.5 inches in height. All seat pans were attached postcrash. However, the interior body sidewall, floor, and some seats were displaced due to the intrusion, including the left side row 9, where the seat pan was displaced laterally approximately 4 inches into the aisle⁵⁶ and the seatback was deformed rearward into row 10. The right side row 8 forward wall anchor was sheared off, and the forward and rearward floor posts were bent laterally inward at the sidewall intrusion on the right side of the bus. The right side row 9 seat was shifted laterally into the aisle almost 9 inches. (See figure 14 for interior damage.)

Figure 14. Forward view of interior damage to school bus, rows 8–10.

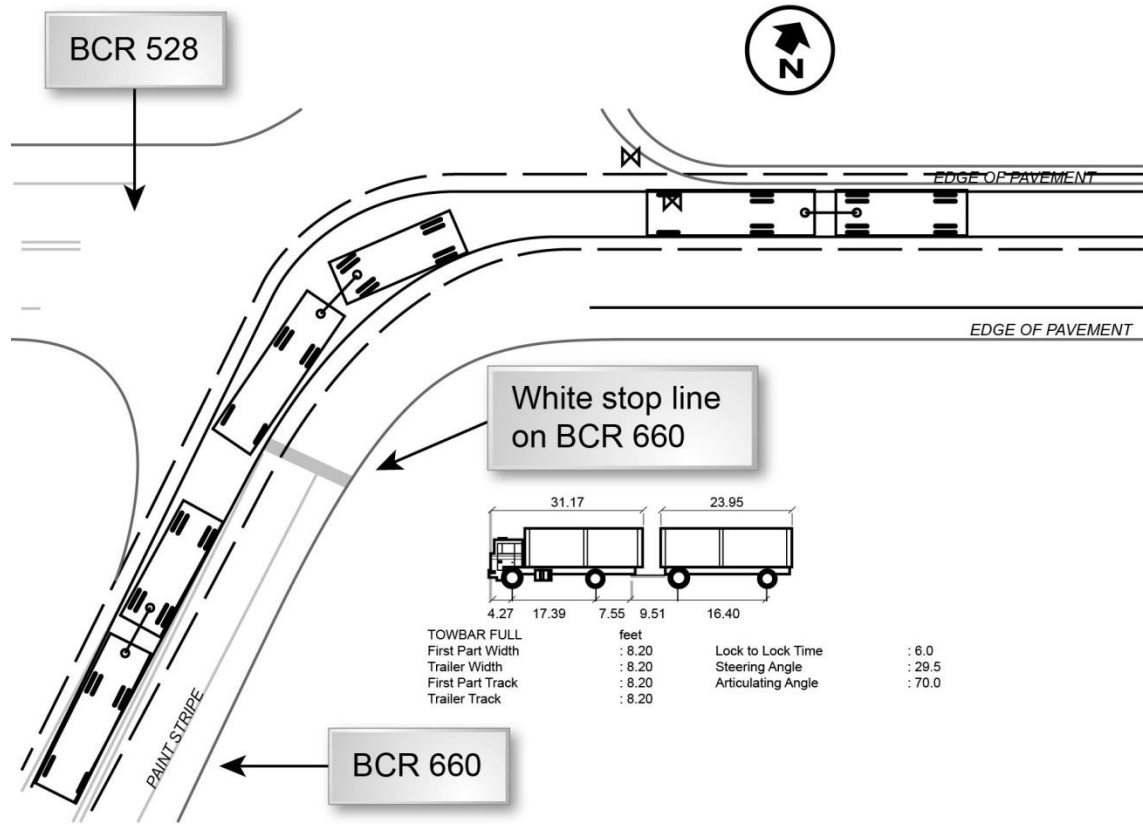
the white stop line been placed closer to the intersection, stopped traffic on BCR 660 could have interfered with or been struck by larger turning vehicles.

Figure 15. Engineering sketch of BCR 528–660 intersection, showing required turning radius for larger designed vehicles. (Courtesy of Burlington County Engineers Office)

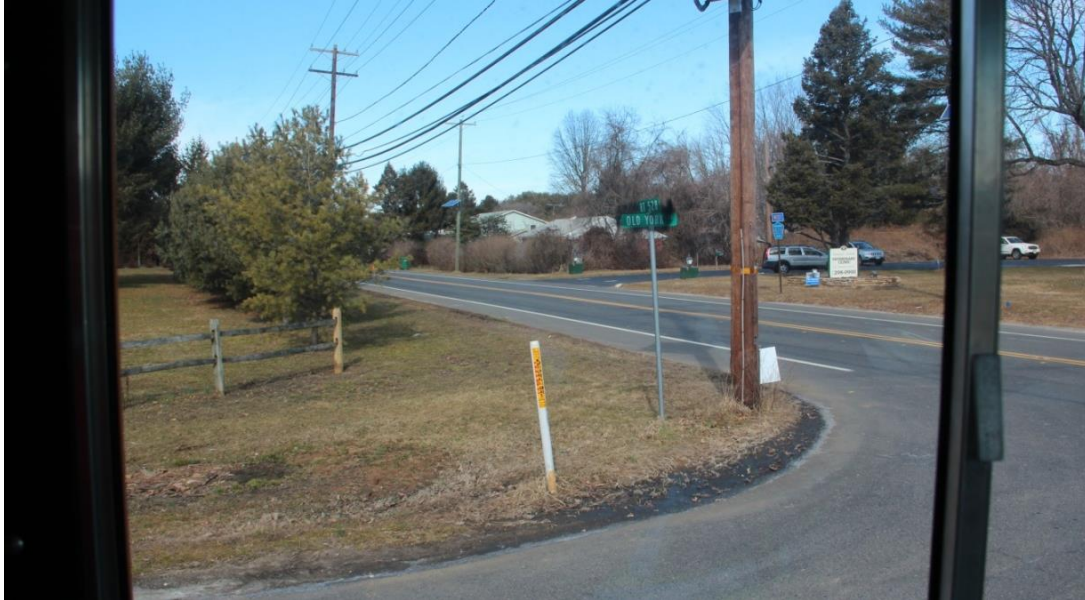
Figure 16. School bus driver sight distance (206 feet) from white stop line on northbound BCR 660.

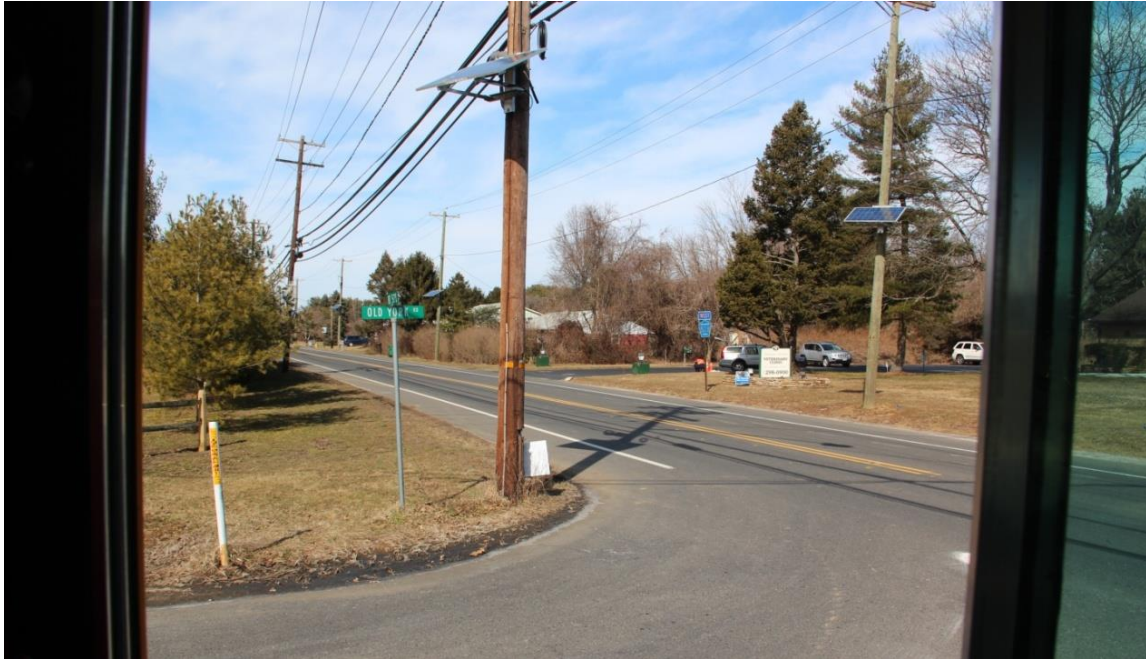
Figure 17. Sight distance from likely school bus driver stopping position on northbound BCR 660.

The BCR 528–660 intersection is at an acute angle of 63 degrees. A right-skewed intersection can affect a driver’s line of sight as well as a vehicle’s recommended departure sight distance (AASHTO 2011, table 9-5, figures 9-17 and 9-22) and results in a longer path to travel across the major road (BCR 528). AASHTO design guidelines indicate that though 90 degree intersections are desirable, intersections with a skew angle of 60 degrees offer similar good qualities. An intersection would not have to be considered for realignment construction unless the acute angle was less than 60 degrees (AASHTO 2011, 9-27; Gattis and Low 1997).

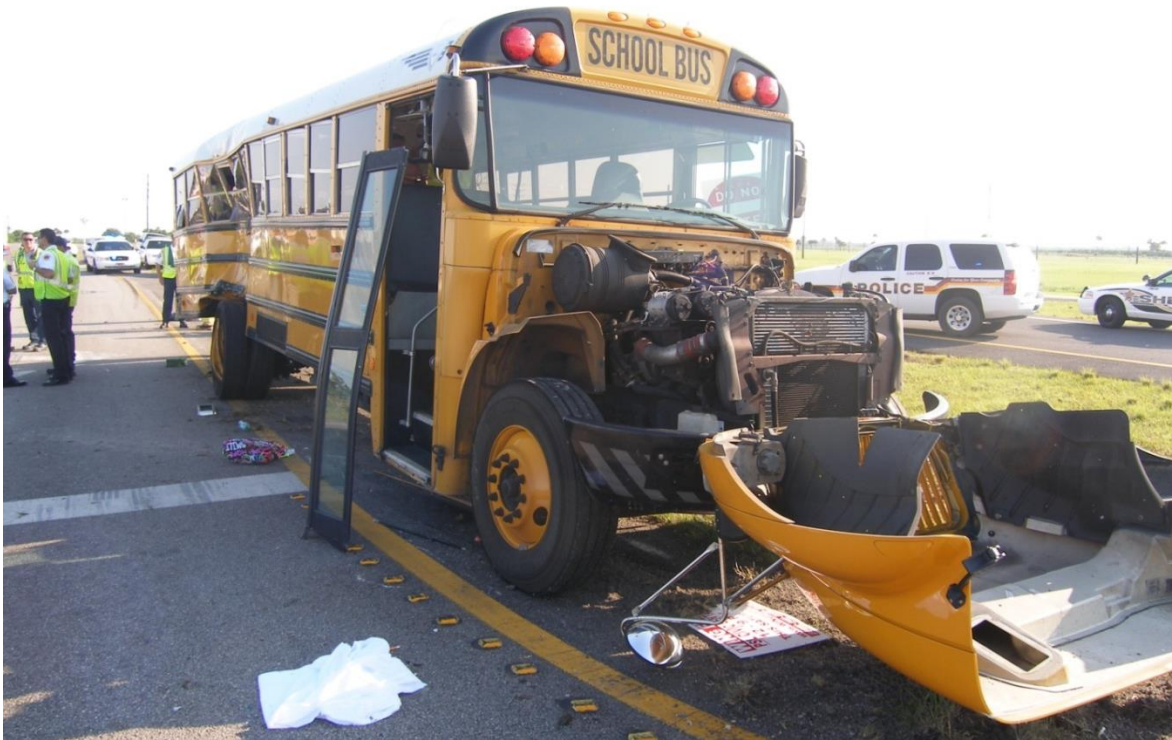
Figure 18. Port St. Lucie, Florida, school bus at final rest position. (Courtesy of Florida Highway Patrol)

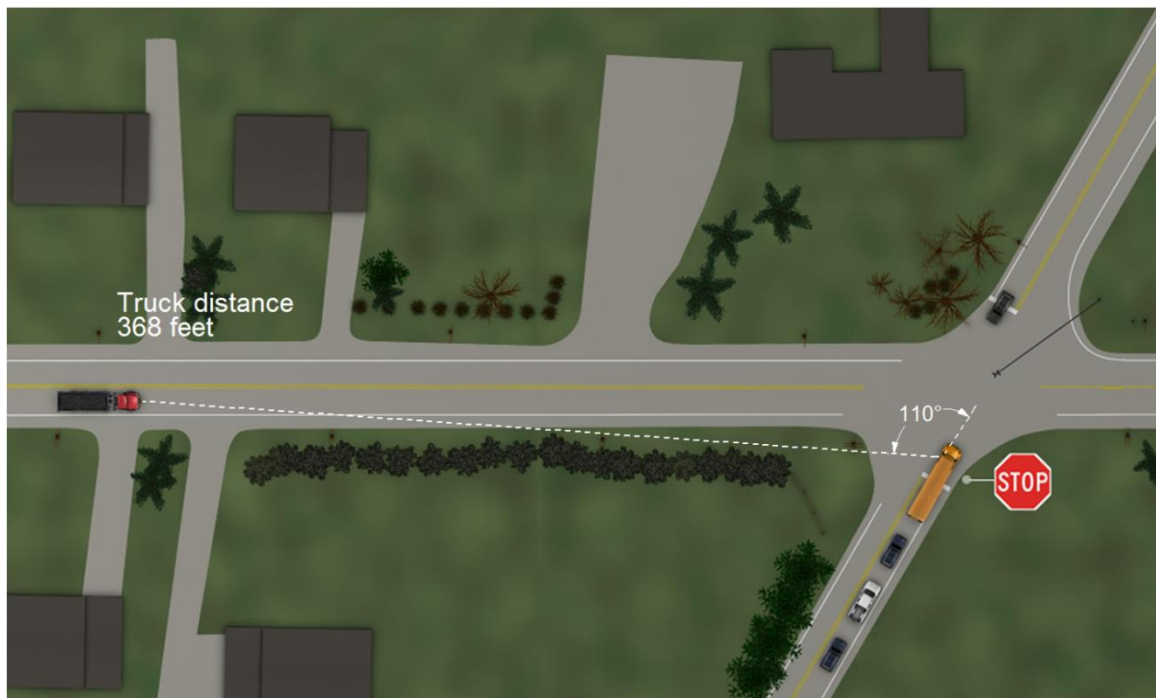
There were no independent witnesses to verify the extent of the school bus driver's scanning behavior at the intersection. Based on accident reconstruction, it was determined that the truck was 368–406 feet west of the AOI when the school bus began to move forward. It is estimated that the approaching truck was approximately 110 degrees to the left from the heading of the bus at this location, as shown in figure 20. However, it took the school bus over 2.5 seconds to travel the first 16 feet before it reached the edge of the BCR 528 travel lane. During this time, there was no evidence to suggest that the bus driver effectively scanned for oncoming traffic as he crossed the intersection.

Figure 20. Accident reconstruction image showing approaching truck and school bus at intersection.

Over the entire 5 seconds the school bus was in motion leading up to impact—from when the bus driver completed his left-right-left scanning of the intersection and then looked forward only, he did not observe the approaching truck. The bus driver’s first indication of oncoming traffic was feeling the actual impact. In a New Zealand study of intersection crashes, failure to observe oncoming traffic was identified as the most significant causal factor (Land Transport NZ 2005). Safe crossing of an intersection requires visually detecting and monitoring traffic and potential conflicts, along with persistent and accurate scanning of the environment. The NTSB concludes that the school bus driver did not effectively scan BCR 528 for oncoming traffic and failed to observe the approaching truck prior to impact.

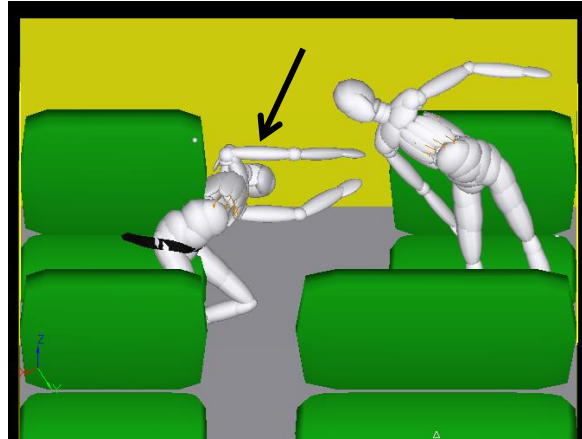
Figure 23. Still image of bus passengers from Chesterfield Madymo simulation, showing flailed upper body of lap-belted occupant (marked with black arrow).

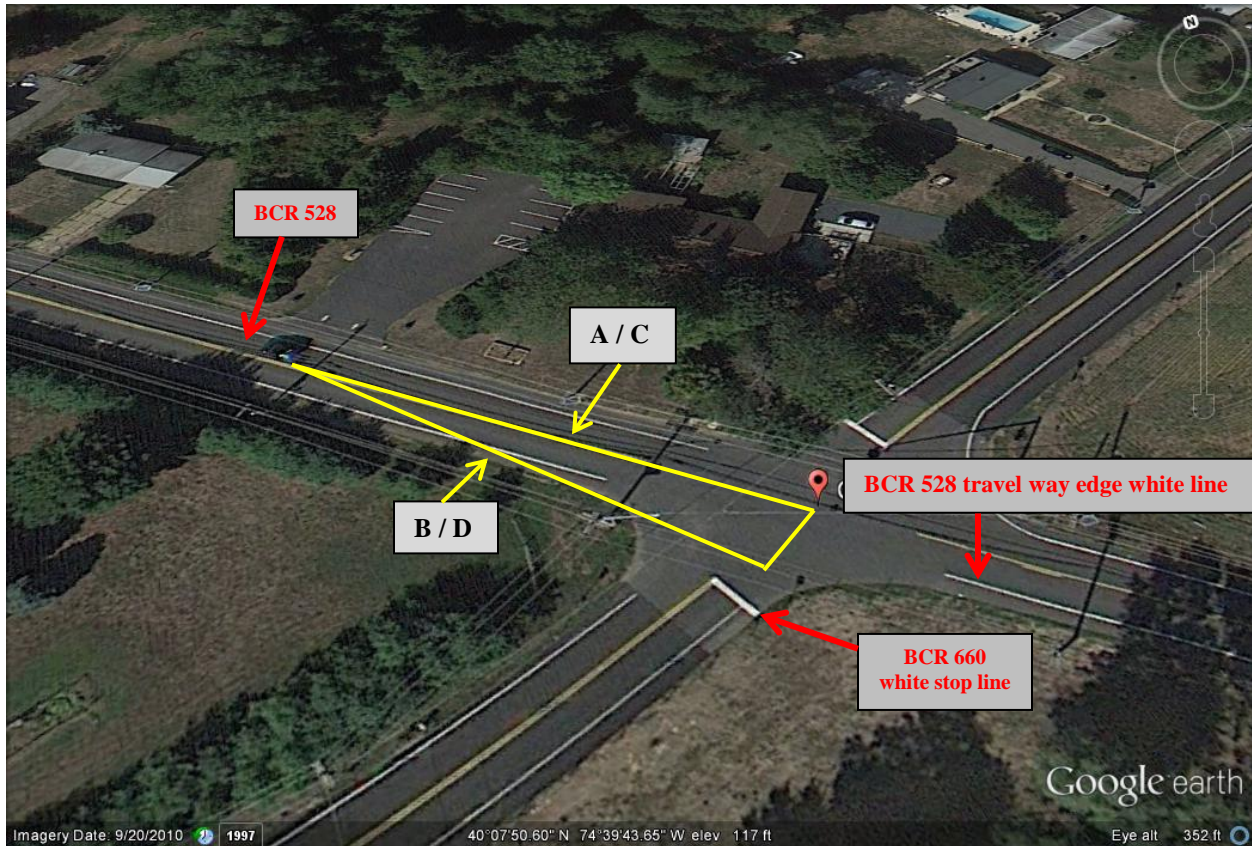
Figure C-1. Aerial view of BCR 528–660 intersection showing parameters for sight distance tests, keyed to table C-1. (Google imagery, September 20, 2010)
